Subject: Temporary Hardware Change: Transmitter terminal board – Alternate pluggable connectors

TB030 Rev:03
Priority:6
Page 1 of 9

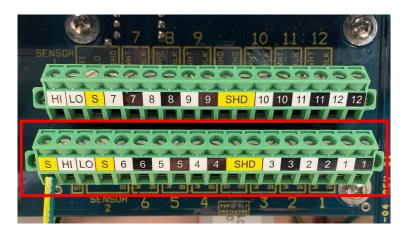
18-position pluggable Sensor I/O connector, with 45° wire entry, used for sensor head cable wire pairs 1-6 and the Sensor 2 (4-20mA) Input as is indicated in section 6.3 of the installation manual

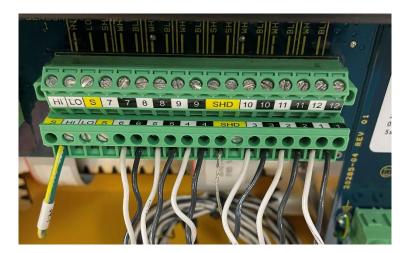
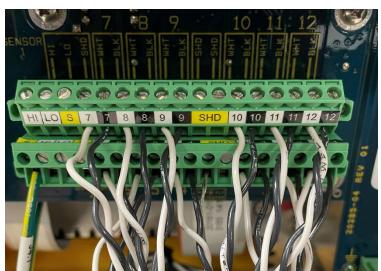
Although the terminal board itself is silkscreened to indicate the proper wire pair and color termination points the sticker affixed to the pluggable connector indicating same wire pair and color termination points may not be as easily viewed as it presently is with the intended connector design. As a result, the person performing the installation and wiring of new transmitters may find it easier to terminate wire pairs 1-6, prior to terminating wire pairs 7-12. (The shield wire in cable can be terminated in any of the four available locations between channels 3 & 4 or 9 & 10)

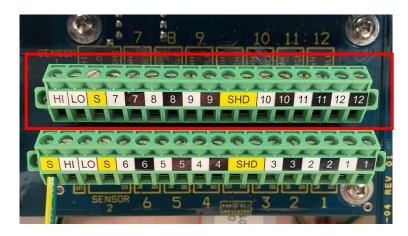
17-position pluggable Sensor I/O connector, with 45° wire entry, used for sensor head cable wire pairs 7-12 and the Sensor 1 (4-20mA) Input as indicated in section 6.3 of the installation manual.
