SONARtrac[®] Technical Note	
	TN0030	
	Subject: Preamp Communication Issues and Debugging	
		Date: 27Nov2018
		Revision 01
		Page 1 of 3

**Subject: Preamp
Communication Issues and
Debugging**

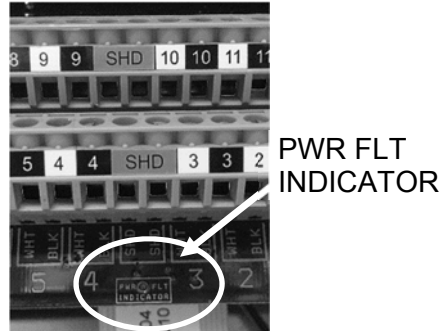
In the decision tree on the following pages the “Power Fault Light” (PWR FLT INDICATOR) location is on transmitter terminal board below the SHLD termination points of the sensor band cable.

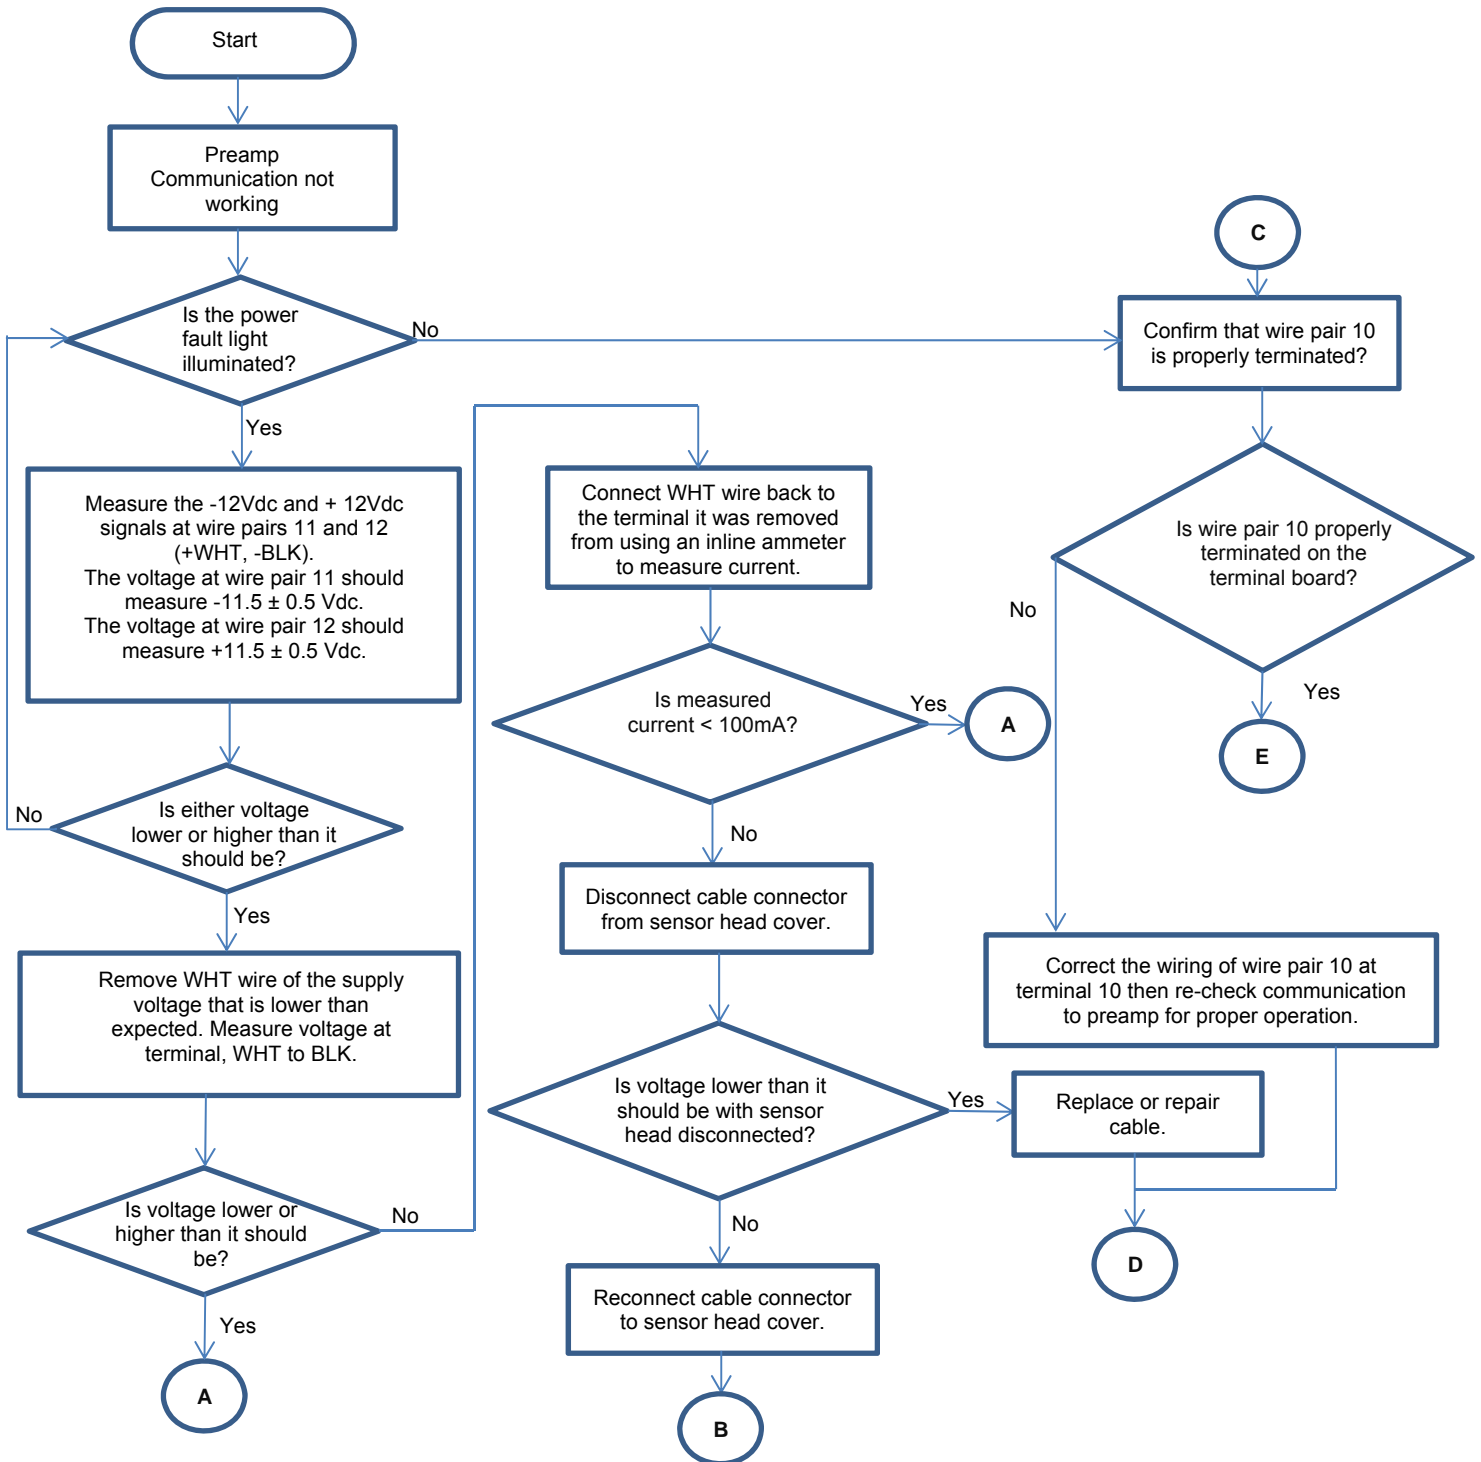
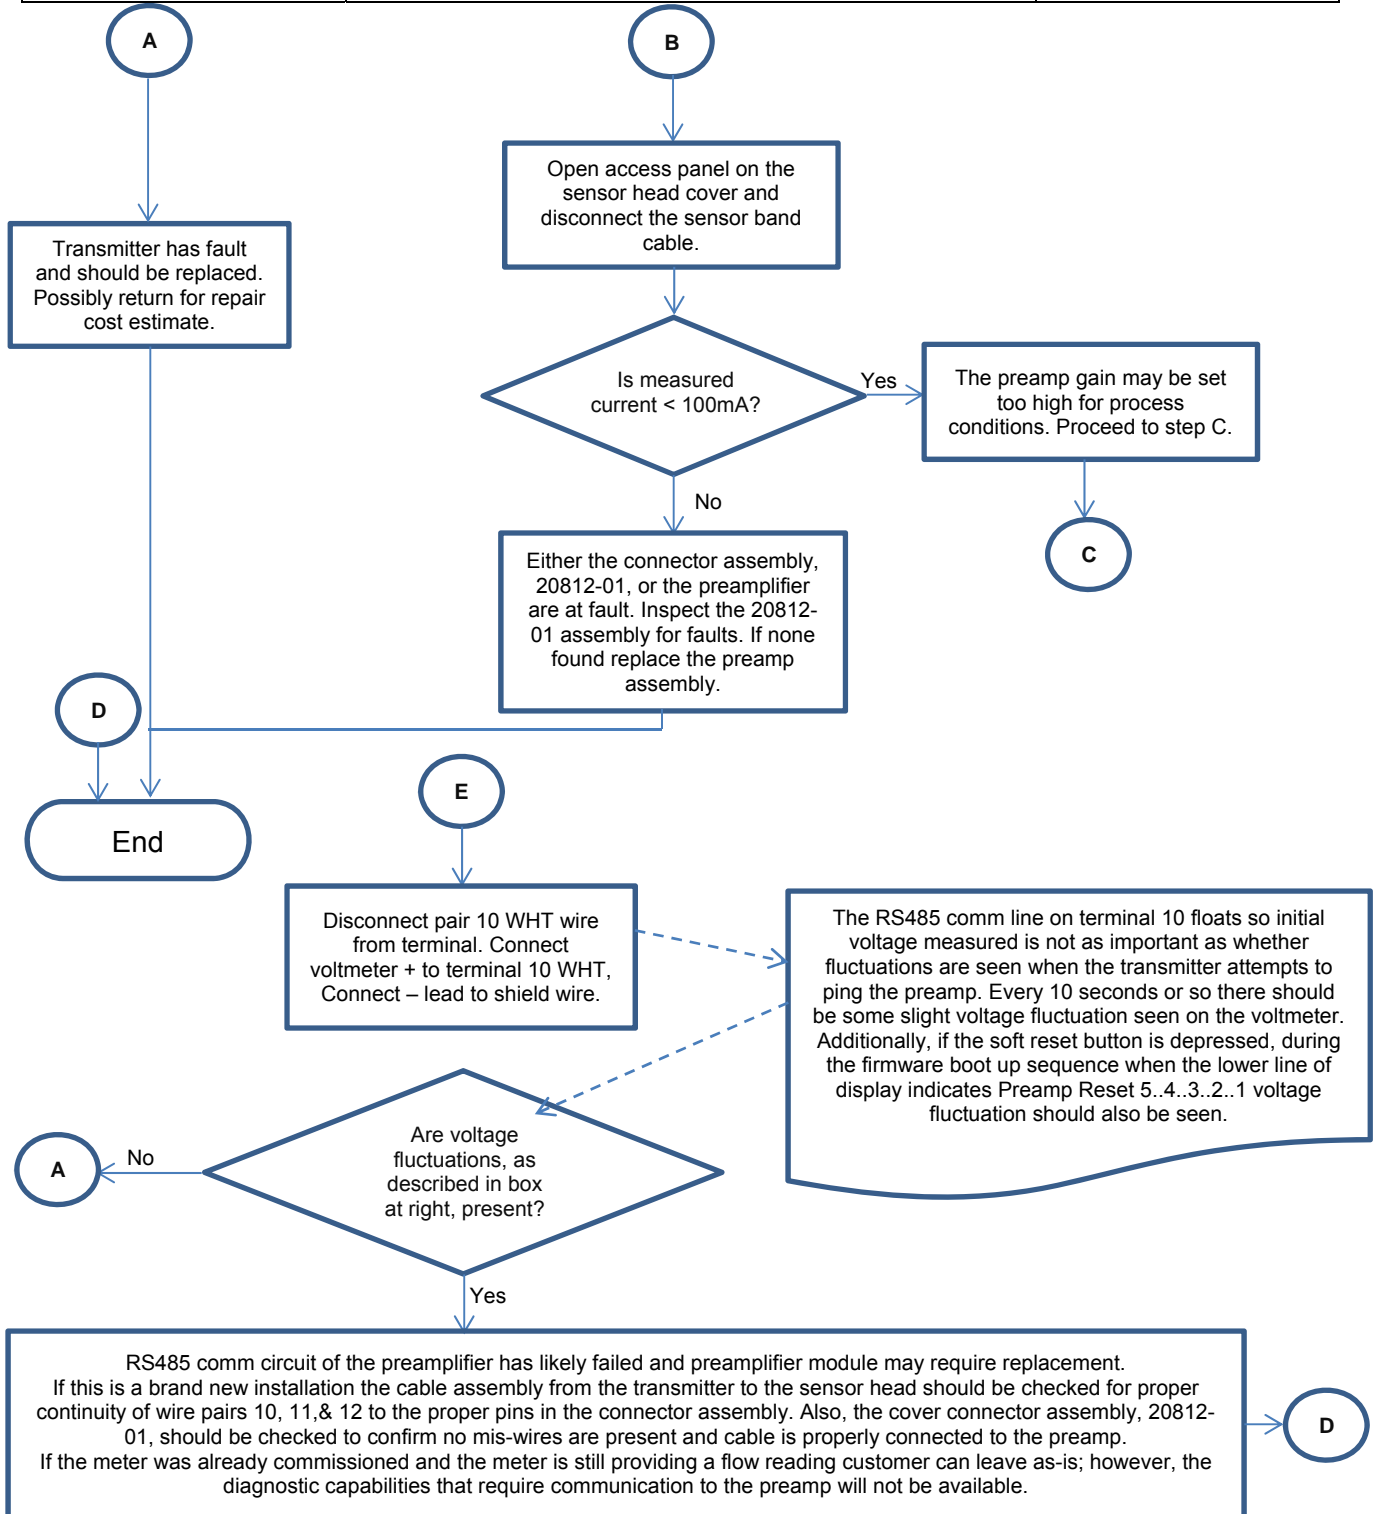
A method for determining the cause of failure follows.
