SONARtrac[®] Technical Bulletin		
	Subject: Transmitter Undetermined Value Option	TB027	Rev: 01
		Priority: 5	
			Page 1 of 3

ECO E14-0037 has been issued that formalizes the release of Firmware Version 04.10.01. This firmware contains a new transmitter configuration parameter called “Undetermined Value” option.

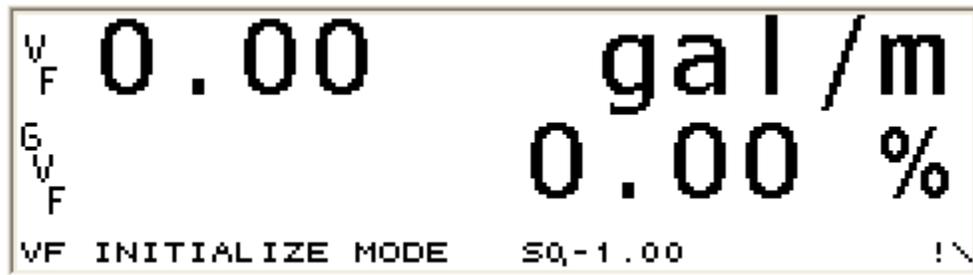
The following is an example of the transmitter display showing bad quality of both VF and SOS measurements in the new 'Zero' mode. Both VF and GVF measurements are showing '0.00' and these values were approached using the damping filter; dropping gradually from their 'good' values all the way past the 'flow cutoff' value.

It is important to note that when "Zero" is selected, the transmitter display will read 0 but there may still be flow (below SONARtrac ability to read) in the system.
