SONARtrac® Technical Note		
	TN0030 - Subject: Preamplifier Communication Issues and Debugging (Legacy SONARtrac)	Date: 23Jul2025	
		Revision	02
		Page 1 of 4

Problem: Provide a method for determining preamplifier communication issues and how to isolate problems with the preamplifier.

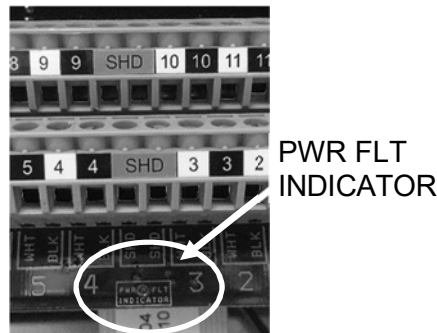
In the decision tree on the following pages the “Power Fault Light” (PWR FLT INDICATOR) location is on transmitter terminal board below the SHLD termination points of the sensor band cable.

The typical mA draw on the -12Vdc and / or +12Vdc preamp power lines at terminal 11 or 12 on the terminal board is ≈90mA. Current limiting (PWR FLT light illuminates) occurs at ≈170mA.

IMPORTANT: Prior to trouble shooting ensure the wire pairs number 10, 11, and 12 are properly attached to their mating terminals (10 WHT/BLK, 11 WHT/BLK, 12 WHT/BLK).

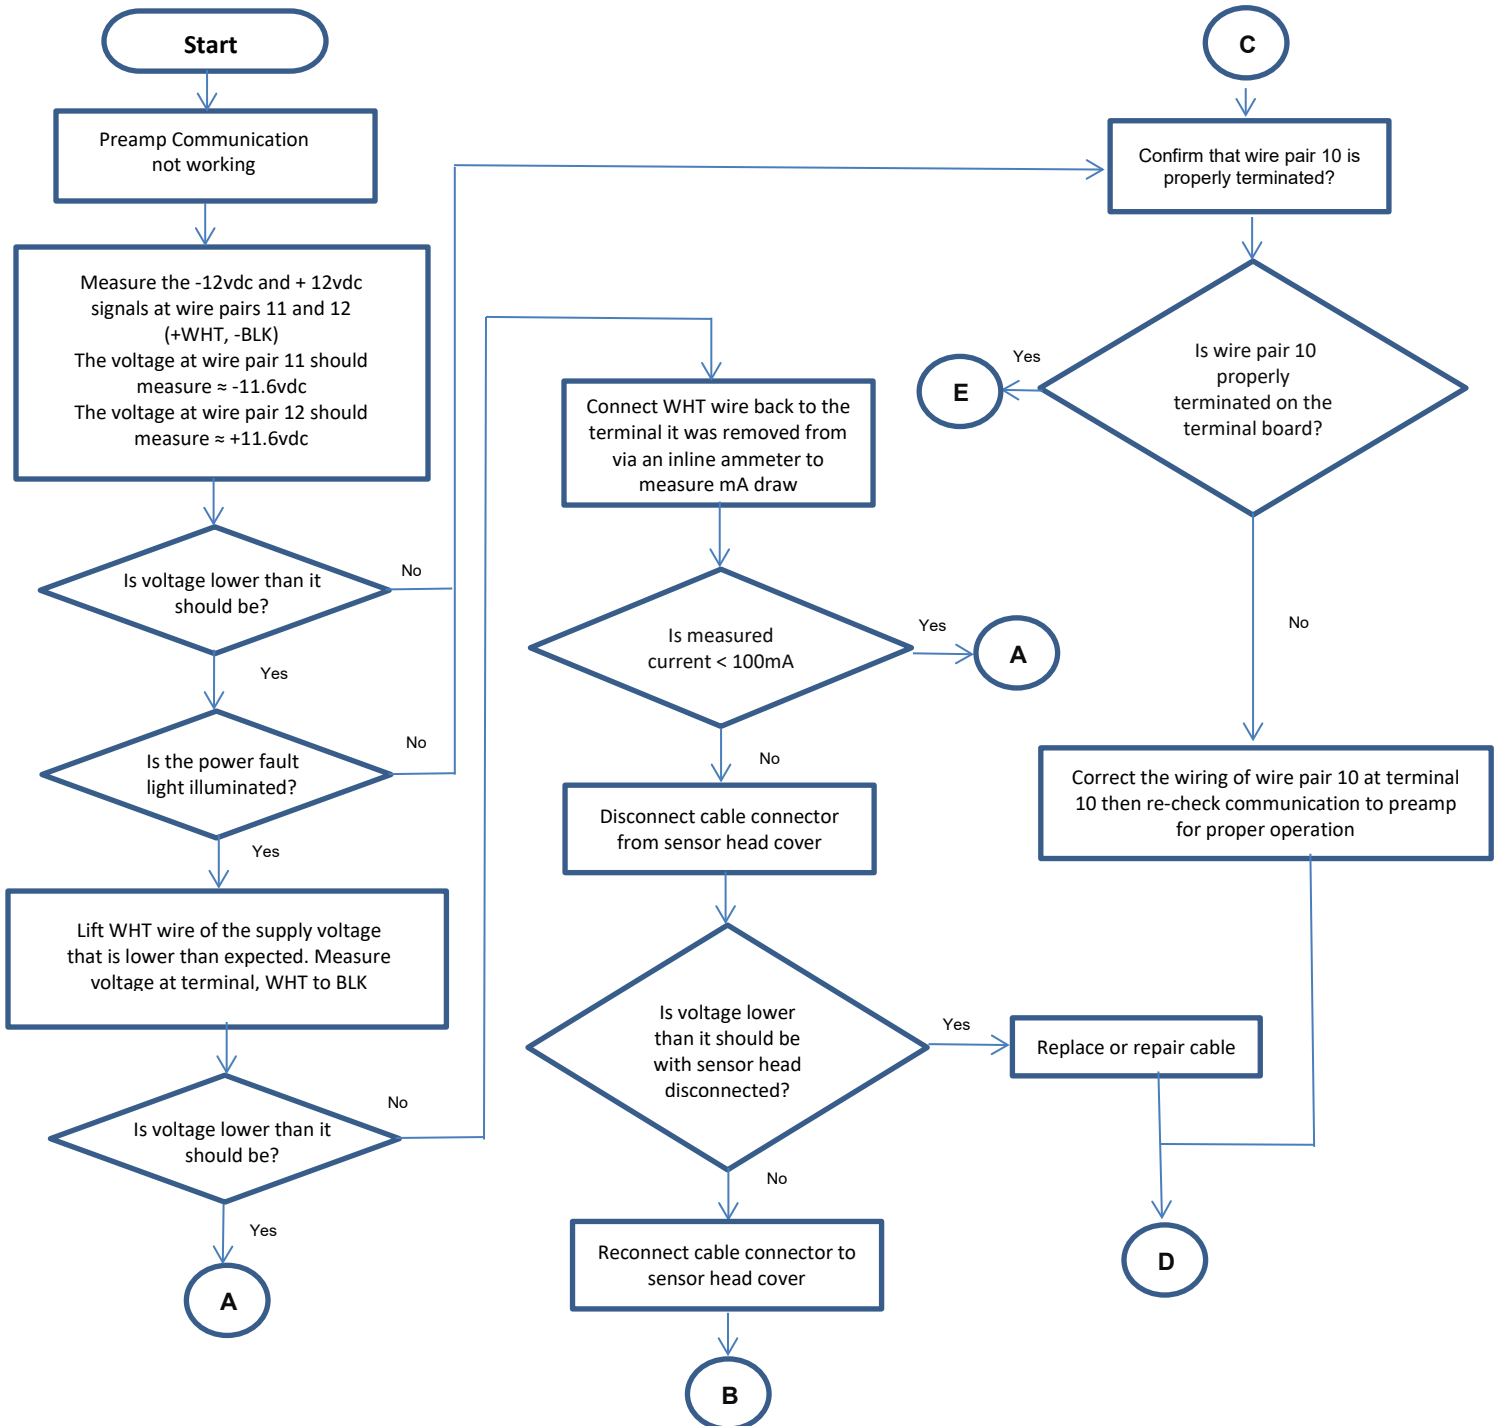
Isolating cause of failure

A method for determining the cause of failure follows.
